## Mason Jewett Field Airport

### Runway 10-28 and Taxiway B Improvement Program

# Preliminary Engineering Evaluation Report

**June 2026**

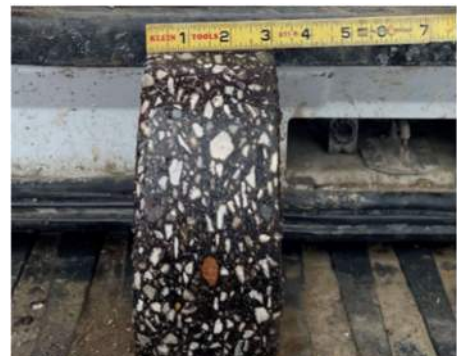
Figure 2 - Runway 10-28 Pavement Core

The runway pavement section consists of an asphalt surface course underlain by a granular base course. The asphalt surface course averages approximately 3 to 3.5 inches thick, with isolated boring locations indicating thicknesses ranging from as little as 2.5 inches to as much as 7 inches. See photograph provided in **Figure 2** for a pavement core extracted from Runway 10-28 during the geotechnical investigation.

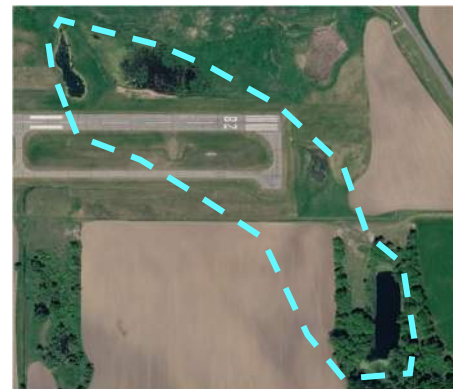
Figure 4 – Assumed Limit of Historically Ponded Areas

At the east end of the runway, the subsurface exploration identified soil conditions at great depth (>10' below the surface) that are characteristic of low-lying, poorly drained, and previously vegetated environments (see Figure 3 for exact description provided in borings logs). These soils were not preliminarily observed at the west end of the runway or taxiway, suggesting that they are in-situ, hydric or organic soils that were not removed during the original construction of these pavements. These conditions likely correspond to historic ponded areas now situated north and south of the runway and taxiway. See **Figure 4** for assumed limit of historically ponded area). The presence of organic soils – particularly if located within or near the pavement structure - reduces load-bearing capacity and increases the potential for long-term pavement settlement and degradation.

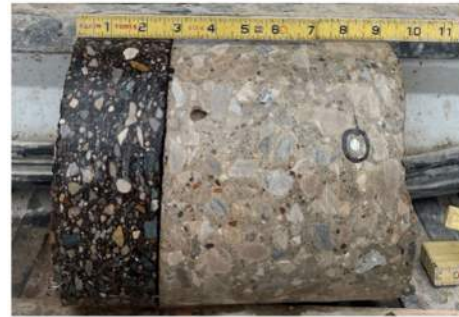
Figure 5 - Taxiway B Pavement Core (Boring TH-07)

The boring log from Boring TH-07, located on Taxiway B just east of the easternmost infield connector taxiway, identified a markedly different pavement structure. At this location, a 2.5-inch asphalt surface course overlies a 7-inch Portland cement concrete (PCC) layer, underlain by granular fill (see **Figure 5** for the pavement core extracted from Boring TH-07). Beneath the concrete, an approximately 48-inch-thick expanded polystyrene (EPS) foam block layer was encountered. Below the EPS foam lies an approximately 5-foot-thick deposit of highly organic peat and marl.

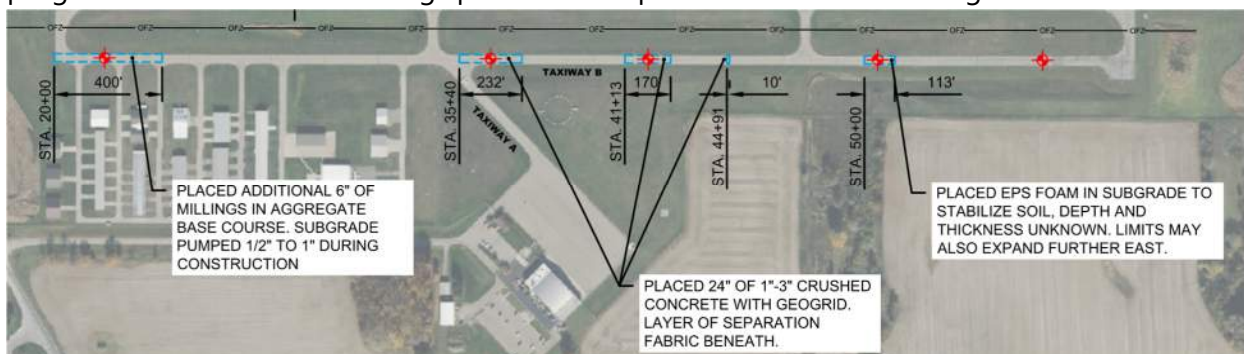
Figure 6 - Historical Taxiway B Subgrade Mitigation Map and 2026 Taxiway Boring Locations

Due to the limited scope of the geotechnical investigation, the full extent of the pavement area containing concrete pavement and EPS foam block was not delineated. However, based on available record drawings, this condition is believed to be the full width of Taxiway B for a length of approximately 113 feet, as illustrated in **Figure 6**.

RS&H conducted a limited review of available record drawings and historical project documentation for the site. A phased reconstruction of Taxiway B was completed between 2007 and 2011, which included reconstruction and realignment of approximately 3,100 feet beginning at the west end of the taxiway. Available record drawings from this project were limited; however, construction field notes indicate that significant subgrade challenges were experienced during construction. Various mitigation measures appear to have been implemented to address isolated areas of subgrade instability – as in the case of the area containing concrete pavement and EPS foam block. These mitigation efforts were more prevalent along the eastern portion of the runway and taxiway.

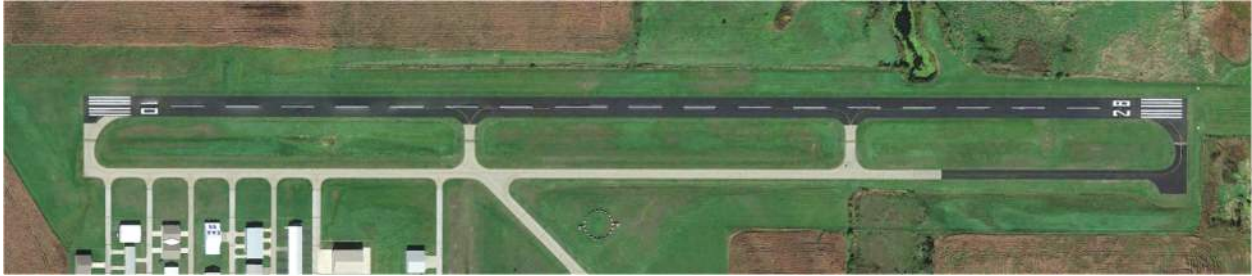
Figure 7 - 2016 Seal Coat Application

In 2016, RS&H understands that an asphaltic liquid seal coat was applied to Runway 10-28 and the east end of Taxiway B. The seal coat was applied to preserve the remaining functional life and reduce the infiltration of water into early-stage pavement cracks. Evidence of the seal coat remains visible today, but the protective nature of original seal coat has largely depleted. Aerial imagery from October 2016 shows the limits of the seal coat application – see **Figure 7**

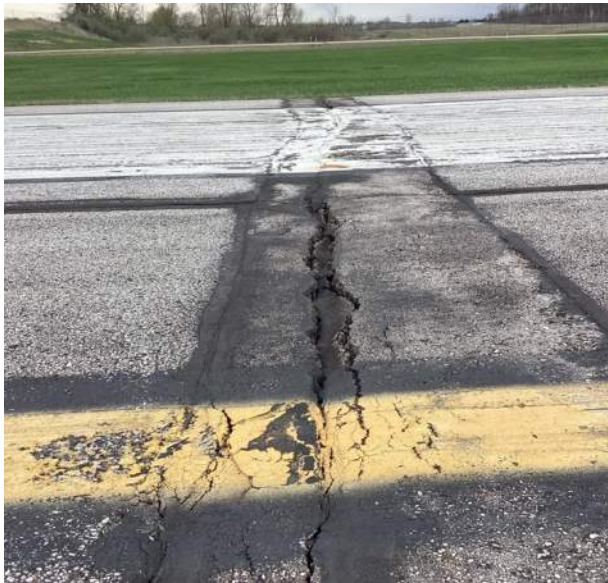
Figure 10 – Significant L&T Cracking on Runway

A pattern of varying deterioration across Runway 10-28 was observed during the site inspection. The eastern half of the runway appears to be experiencing the highest rate of degradation, consistent with the weaker subsurface conditions identified in the soil borings. The western half exhibits comparatively less severe distresses, however the quantity and broad distribution of the observed cracking and pavement deformations still warrant a high-severity classification. The center section of the runway showed a reduction in distress severity and as such was categorized as medium severity.

Current PCI values for Runway 10-28 and Taxiway B support the need to completely restore the pavement to a like-new condition. Observed pavement distresses indicating loss of subgrade strength, evidence of upward migration of fine-grained, moisture-prone soils within the base course layers, and overall age of the existing runway and taxiway pavement also justifies the need to replace the pavements at their full depth. A full-depth pavement replacement project would allow for necessary subgrade improvements and the installation of a drainage layer and integral underdrain system to mitigate the effects of frost heave.

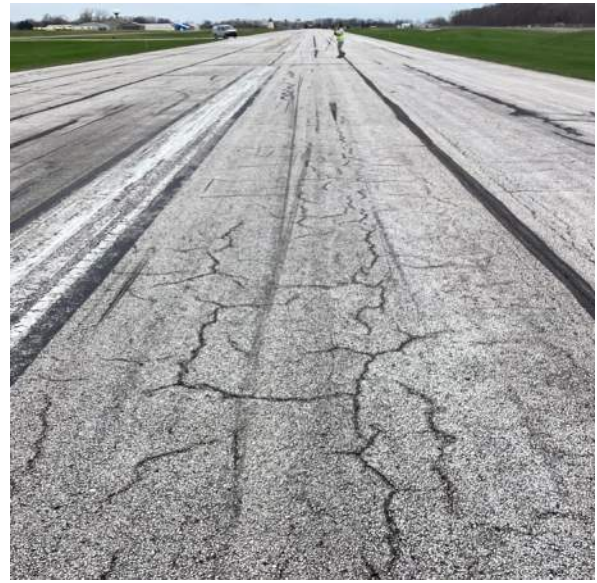
Figure 11 – Alligator & Block Cracking on Runway

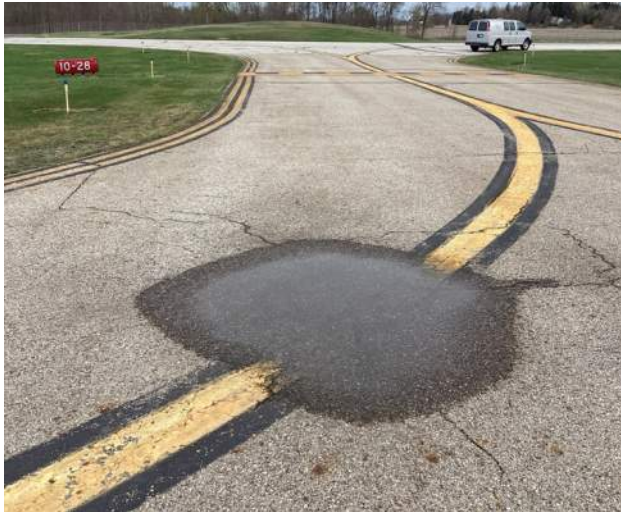
The east end of Taxiway B contained a variety of high-severity pavement distresses, consistent with the same deficiencies identified on the east end of the runway. There was a clear delineation of high severity distresses once aligned with the easternmost historical subgrade improvement limit, as illustrated in **Appendix B**. The pavement distresses located west of this

Figure 12 – Depression on Taxiway B

Pavement at the west end of Taxiway B is exhibiting the least amount of pavement distress at the surface. A limited amount of extended service life could be provided to these pavements by replacing only the wearing course. However, weakness within the subgrade and base course layers would likely cause premature cracking of the new wearing course in only a few years. The future programmed construction of adjacent taxiway fillet pavement in this area would also be impactful to the narrowed and fragile existing taxiway pavement that would remain. The addition of taxiway fillet pavement at the west end of Taxiway B and reconstruction of existing full-strength Taxiway B pavement should occur simultaneously as part of this program.

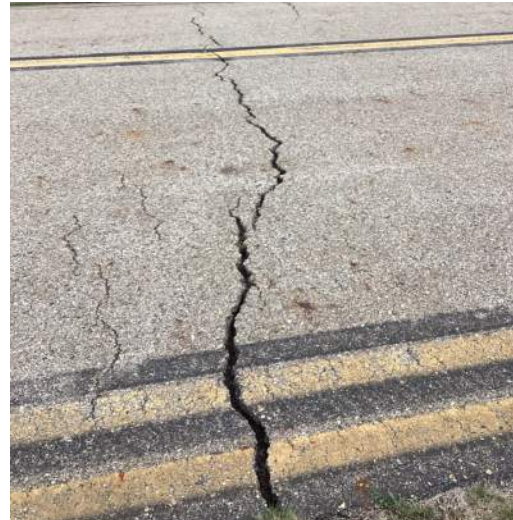
zone, before the intersection of Taxiway A, fluctuated but were not significant enough to warrant a high severity rating. The remaining pavement West of Taxiway A showed the least amount of pavement distress within the project limits and was classified as low severity.

Figure 13 – L&T Cracking on Taxiway B

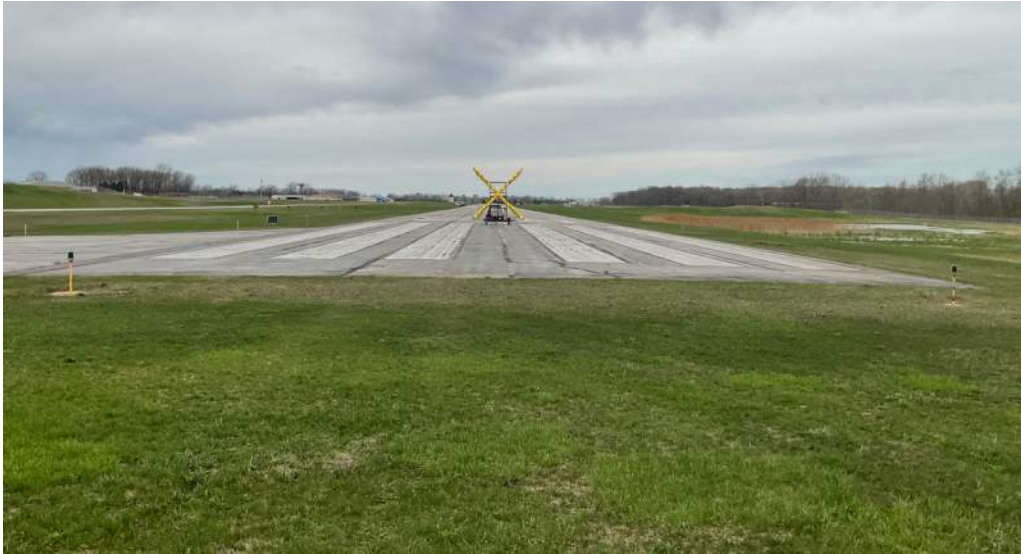
- Runway 28 RSA: The slope beyond the pavement rises to an elevation higher than the runway end, penetrating the clearway (see Figure 9 below). This condition represents a significant safety hazard for aircraft that may overrun the runway during abnormal or emergency operations.

Figure 14 – Photo of Runway 28 Longitudinal Grade within Runway Safety Area (RSA)

The longitudinal grades of the existing connecting taxiways were not reviewed as part of this report. A full evaluation would be required during the design phase of this program to ensure compliance to FAA standards. The existing non-standard RSA grade conditions should be corrected as part of this project to ensure the continued safety of aircraft operations at TEW.

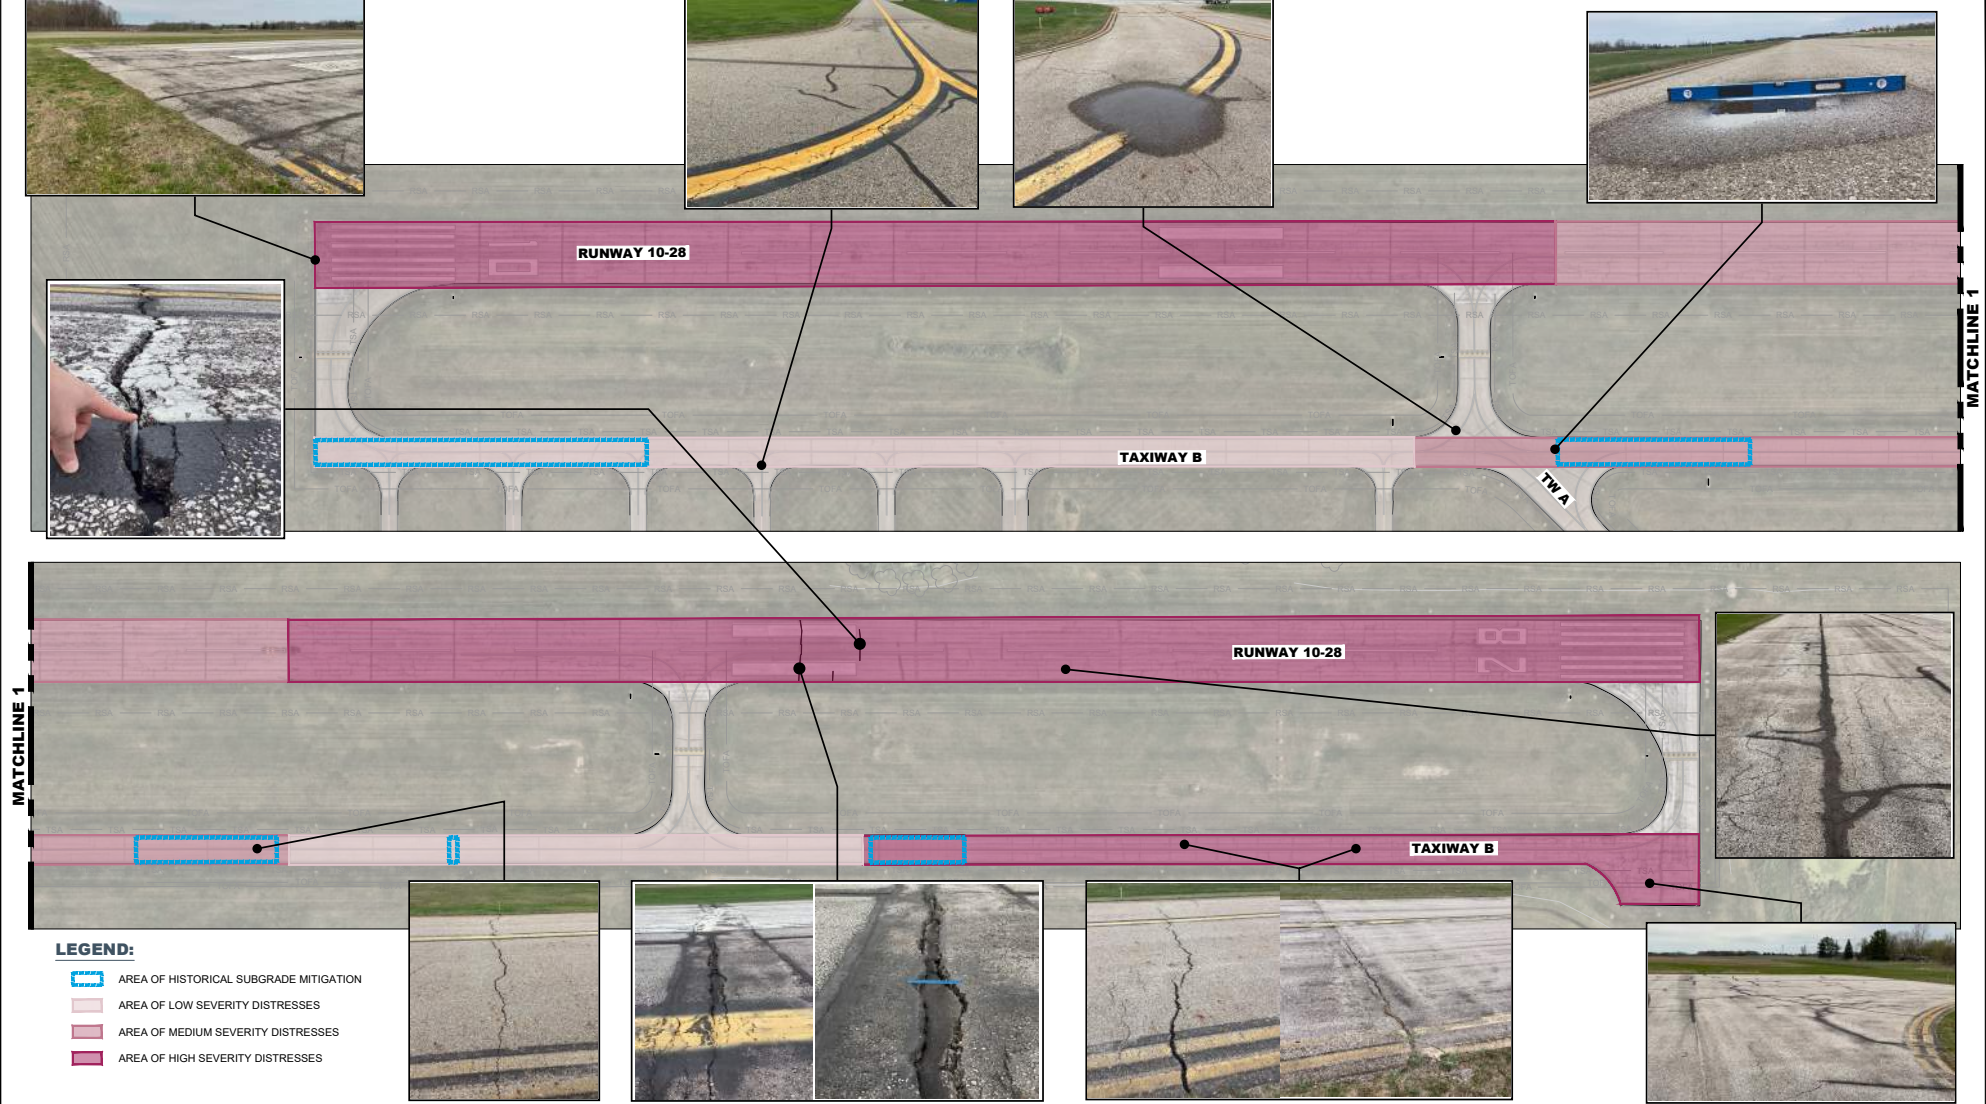
Pavement Distress Severity Generalization Map and Site Photos

During the site inspection, RS&H prepared a map which generalizes pavement areas as high, medium and low pavement degradation areas based on the severity and frequency of pavement distresses observed. A map showing the runway and taxiway pavement areas grouped by level of degradation is provided in **Appendix B** of this report and further discussed below.
