## Mason Jewett Field Airport

### Runway 10-28 and Taxiway B Improvement Program

# Preliminary Engineering Evaluation Report

**June 2026**

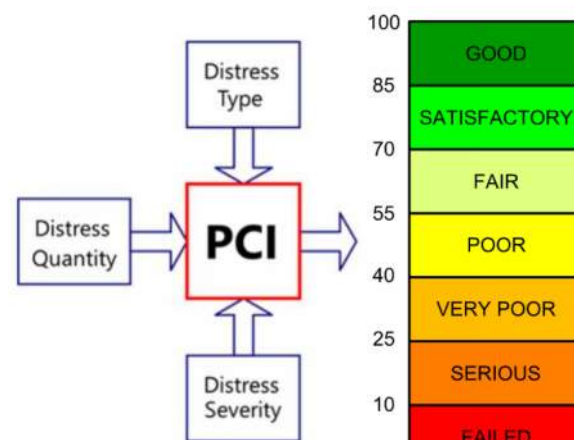
Figure 9 - Pavement Condition Index (PCI) Legend

The PCI is a numerical indicator of the structural integrity and surface condition of a pavement. PCI values range from 0 to 100 where 0 indicates a failed pavement and 100 represents a new pavement.

- Pavements with a PCI value above 70 are considered to be in good condition and typically require routine maintenance
- Pavements with PCI values between 70 and 55 may be effectively rehabilitated to extend their service life.
- Pavements with PCI values below 55 generally exhibit more advanced deterioration and are better suited for full-depth reconstruction rather than rehabilitation (FAA AC 150/5320-6G, Chapter 4).

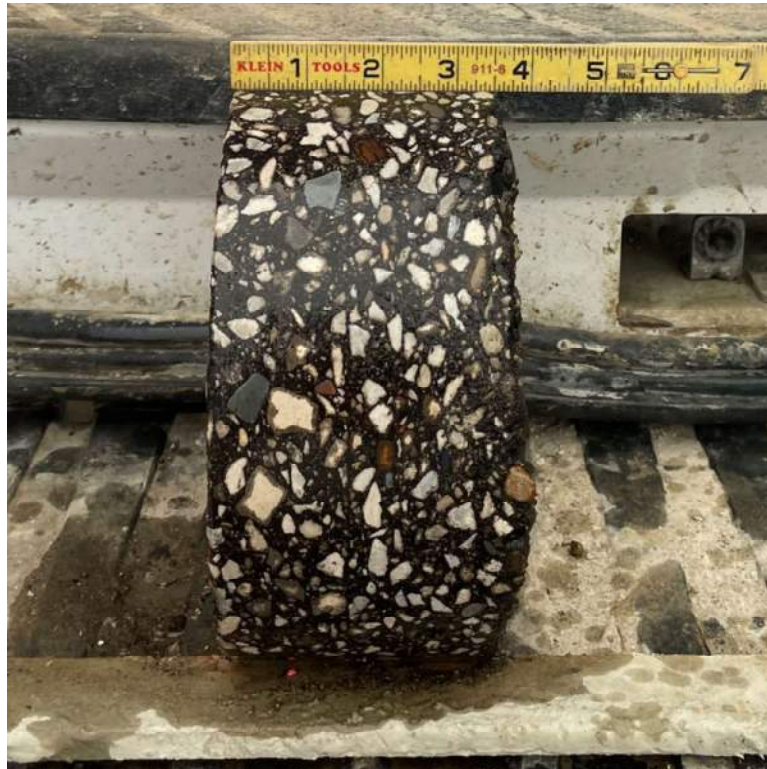
**TH-01**

| Boring No. | Base layer thickness | Subgrade soils encountered below the base layer |
|---|---|---|
| TH-01 | 8.5 inches | Loose fine to coarse gravel with sand fill |

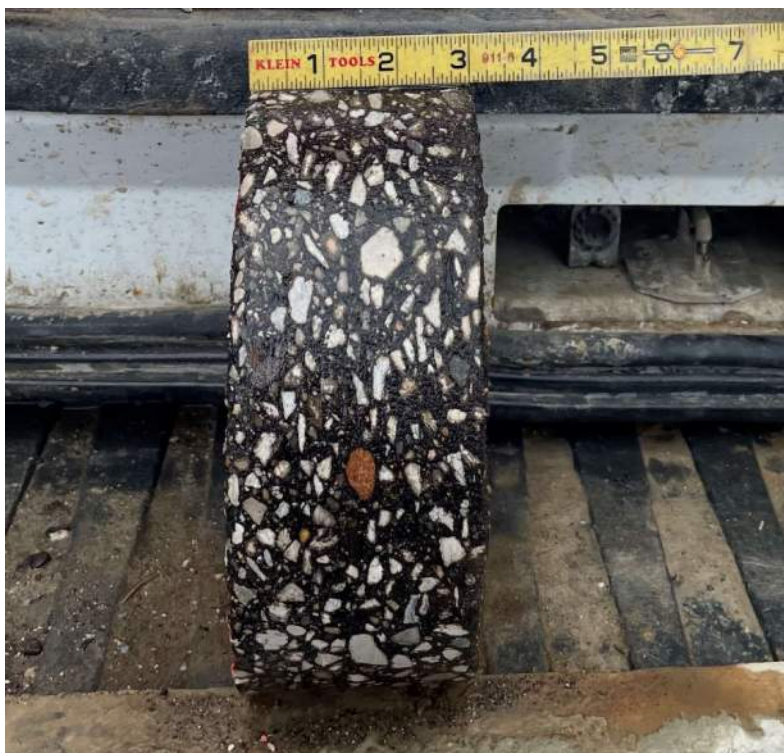
**TH-03**

| Boring No. | Base layer thickness | Subgrade soils encountered below the base layer |
|---|---|---|
| TH-03 | 8.5 inches | Very loose clayey fine to medium sand |

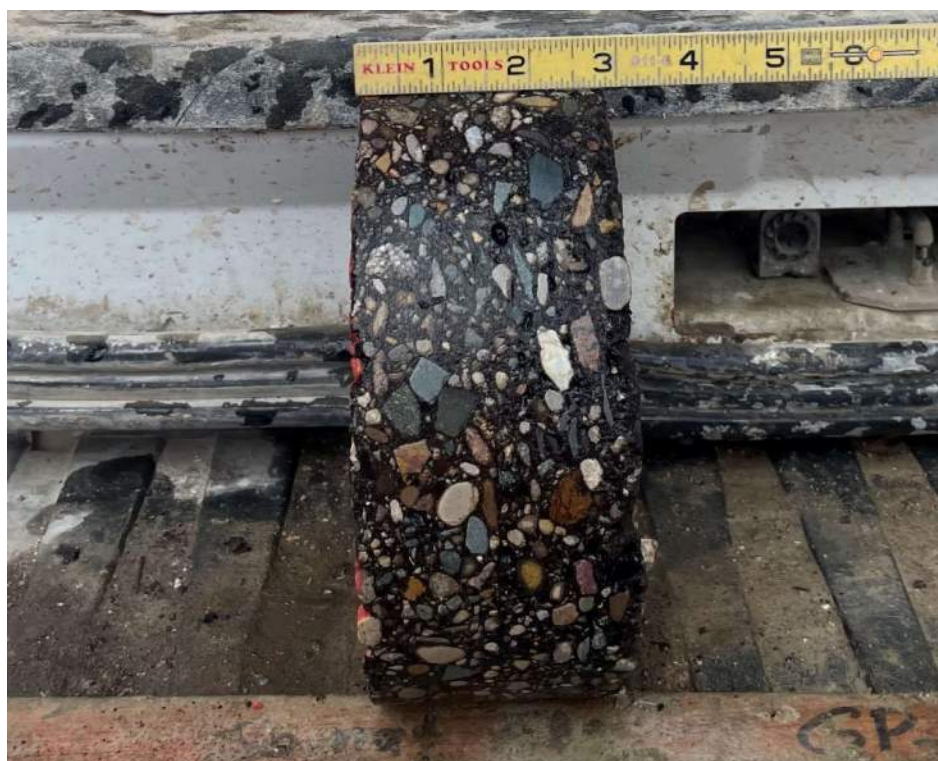
| Boring No. | Base layer thickness | Subgrade soils encountered below the base layer |
|---|---|---|
| TH-10 | 3.5 inches | Fine to coarse sand fill over loose clayey fine sand fill |
